Intelligent Design and Intelligent Failure

Introduction

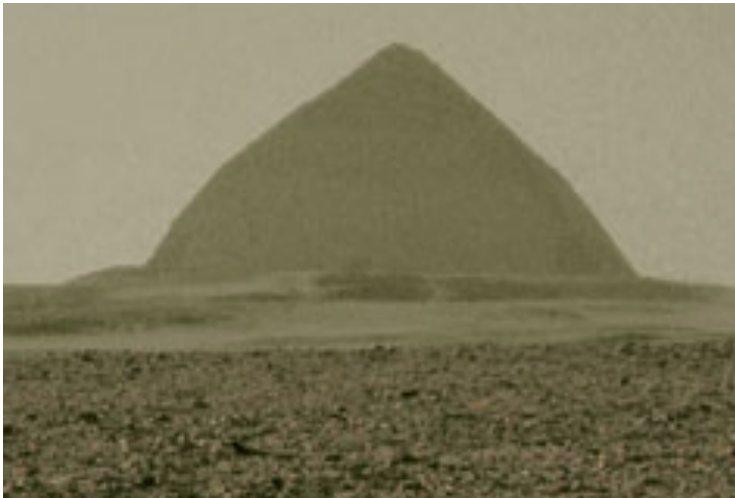
Before I go forward into space, I would like to set the way back machine to ancient Egypt: 4600 years ago. Egyptian king Sneferu was known for building two pyramids. The first was known as the Bent Pyramid. As construction proceeded, his architects realized the walls were too steep and unstable. So they reduced the angle to prevent collapse. Lessons learned from the Bent Pyramid were employed in his next creation, the Red Pyramid. This was a true smooth sided pyramid. The failures and successes of Sneferu informed his son Khufu who built one of the 10 wonders of the ancient world: the Great Pyramid at Giza. The success of new engineering endeavors are always linked to lessons learned from previous engineering failures. Failure analysis is engineering's evolutionary mechanism.

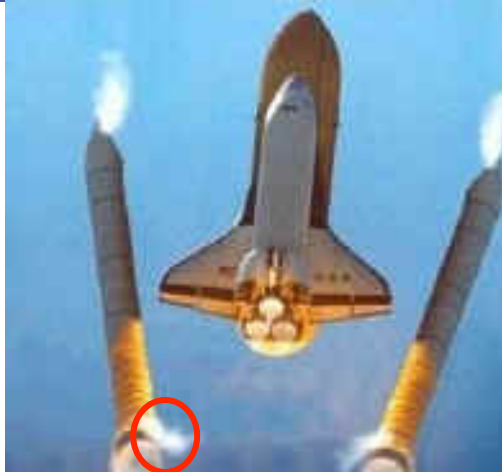
Failure of a Booster Separation Ordnance Cable

I am now going to introduce you to a simple yet critical part of the Space Shuttle. It is a cable that fired explosive bolts that initiated the separation of the Solid Rocket Boosters from the Shuttle. These cables were reused for many years, until one failed to fire its respective bolt. Fortunately, most critical systems have a backup, so in this case, the backup fired and safely separated the booster. As you can see in the x-ray picture, the cable broke in the conductor itself. How many of you pull a plug out of the wall by pulling on the wire rather than grasping the plug? This is what happens when you pull a plug out by the wire too many times. How could this happen to critical flight hardware? Flight hardware is extensively tested and handled with kid gloves, but a subtle change in perception led to unintended consequences. After an SRB was recovered, all the cables were removed, but the technicians considered everything “flown” hardware so they were not very careful about removal. They thought the rigorous pre-flight testing, before reuse, would weed out any problem cables. They didn’t count on the elastic nature of the rubber coating pulling the broken wires together. This gave a positive electrical continuity check, and a failure at 2Gs of acceleration on launch. A simple shift in perception of flight versus flown hardware could have been disastrous.

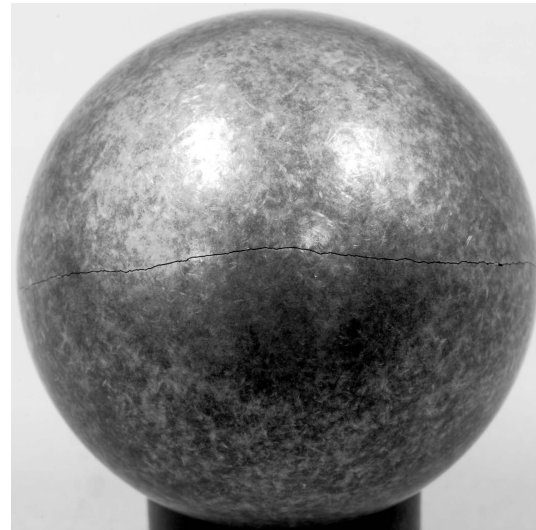
Cracked Ball from Orbiter Ball Strut Tie Rod Assembly

As the Space Shuttle began its second decade of service, a number of issues arose related to its age. Each Shuttle had been designed to fly 100 times, but some components were failing early. One such component was used in the liquid oxygen feed lines to allow for thermal expansion and contraction. In the spring of 2002, a routine inspection of the liquid oxygen feed lines on the Space Shuttle Discovery identified a cracked ball in a Ball Strut Tie Rod Assembly (BSTRA) joint. This ball was about two inches in diameter and was made from an alloy known as Stoodly #2: a cobalt matrix hardened by chromium and tungsten carbides. It is a very high temperature alloy used at very low temperatures. Why? It had been used in similar joints on the Saturn V rocket, so it was accepted as a heritage material for the new Space Shuttle. The cracked BSTRA ball from Discovery had actually been sand cast in 1978, so at the time of failure, it was 24 years old. The ball failed because it had sand inclusions that created a small crack that opened with successive thermal shocks on cool down in liquid oxygen. During the investigation we found three different casting methods were used and there were three different ball sizes. So to determine the safety of all BSTRA balls used in the Space Shuttle, a series of thermal shock tests were conducted to see if we could get any other balls to crack. We also conducted stress tests to see if we could get a ball to completely break apart. We worked through Christmas into the New Year to prove the safety of the BSTRA balls. With any flight that occurs after a significant failure analysis activity, we always have heightened anxiety. On January 16, 2003 we were relieved when the Shuttle Columbia was successfully launched. The feed lines and engines worked flawlessly.

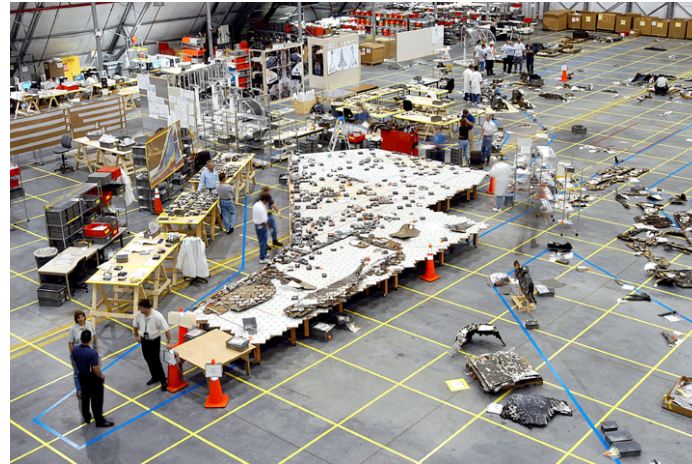
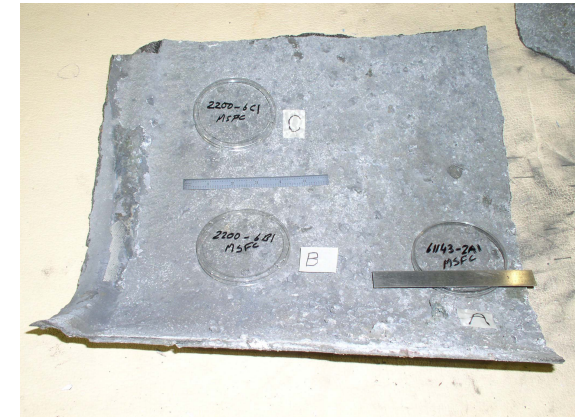
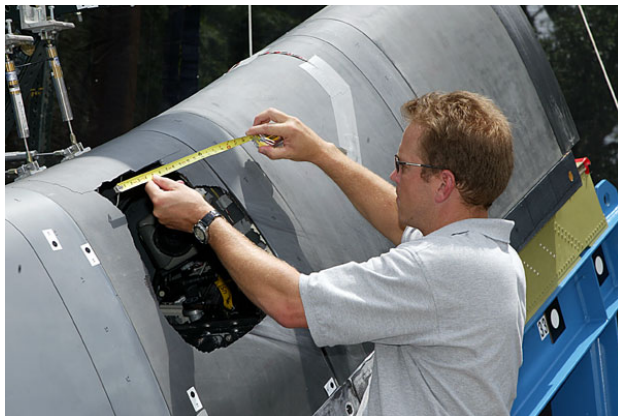
Columbia Investigation

help in the debris recovery, but that wasn't my job. My job was to wait for enough debris to be collected in order to start some meaningful analysis. One post launch concern had been a large impact from insulating foam off the External Tank. It hit orbiter's wing leading edge, but foam had been hitting the orbiter since STS-1. It was not a significant concern. During reentry, initial alarms indicated a problem with the landing gear before loss of communication. So our first focus was on the landing gear. It wasn't until the discovery of Columbia's flight data recorder that extra sensor data became available. Columbia was the first Orbiter to fly in space, so it had been wired with extra sensors connected to a data recorder. This computer was not hardened like a passenger airliner's black box, so it was a miracle any data survived. The first thermal sensor to show a temperature anomaly was in the left wing's leading edge. This was where the loose insulating foam hit during launch. So how do you prove foam caused damage when it would have all burned away? It took three months to collect enough wing leading edge debris to start analysis. We sectioned molten deposits at different locations, and compared their chemical analysis to the alloys used in the wing leading edge. The results were clear. Molten metal and insulation went down in layers. We found the molten remnants of attachment hardware for the wing leading edge panels at only one location on the left wing. This pinpointed the location where hot gas first crept into the left wing. Modeling of the foam impact trajectory coincided with this location and subsequent foam impact testing showed high velocity foam of a certain size could damage the brittle high temperature wing leading edge material. Unknown amounts of risk had been regularly accepted as foam continued to hit the Orbiter on each and every flight. The loss of Columbia taught us that past success did not guarantee future success.

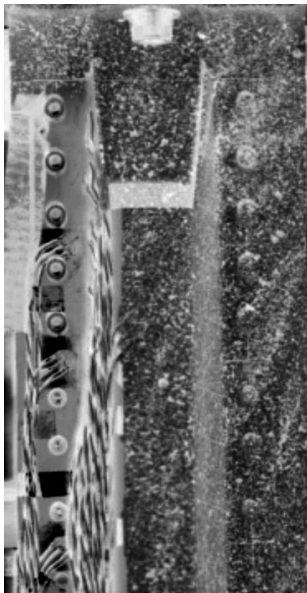
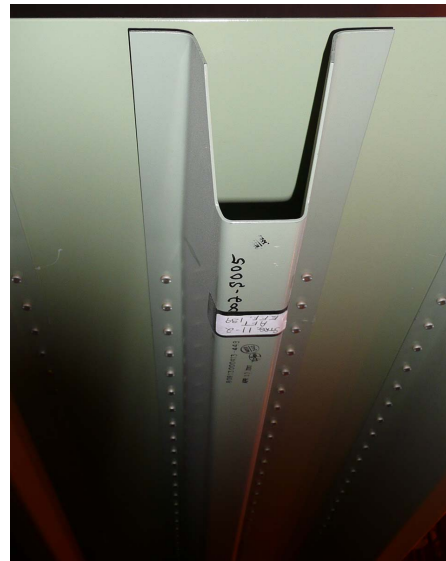
External Tank Stringer Cracking

After Columbia, NASA decided to set a retirement date for the Shuttle program. We would finish building the International Space Station and retire the fleet by 2010. We came close to meeting that deadline until a unique failure halted the launch schedule in November 2010. Stringers used on the intertank structure of the Space Shuttle External Tank had cracked. The damage was only found after a launch scrub, and inspection of the External Tank revealed protruding insulation foam. The construction of the intertank structure used standard skin-stringer construction methods employed in aircraft. Metallurgical and process evaluations found the material used in the construction was within specification. Since the material and construction process were good, why were some stringers cracking? The answer lay in defining a box around the material properties. The specification called out a minimum strength value, but processing variability led to some very strong stringers. As materials get stronger, they generally become more brittle. In the case of the intertank stringers, some were too strong which reduced their fracture toughness. Thermal contraction during the tank filling operation was bending the ends of the stringer feet resulting in cracking of a few stringers. The fix was very simple, although too late to affect the Space Shuttle program. Future intertank stringers would have a maximum as well as a minimum strength requirement.
